Analyzing Defects of Solar Panels under Natural Atmospheric Conditions with Thermal Image Processing

Akash Singh Chaudhary¹, D.K.Chaturvedi²

How to cite this paper: Akash Singh Chaudhary, D.K.Chaturvedi , " Analyzing Defects of Solar Panels under Natural Atmospheric Conditions with Thermal Image Processing ", International Journal of Image, Graphics and Signal Processing(IJIGSP), Vol.10, No.6, pp. 10-21, 2018.DOI: 10.5815/ijigsp.2018.06.02

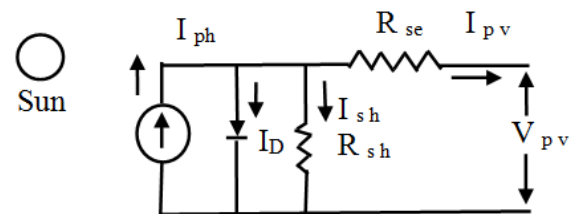
The solar radiations emitted by sun are converted into electrical energy by solar cells. These solar cells are the smallest element of solar module. The equivalent circuit diagram of a solar cell is given below in fig. 1.

Fig.1. Equivalent circuit diagram of a solar cell

The output parameters of a solar cell are output current I_{pv} output voltage V_{pv} . The basic output equation of a solar cell can be written as:

$$I_{pv} = I_{ph} - I_0 \left(e^{\left(\frac{V_{pv}}{\eta V_T} \right)} - 1 \right) - \left[\frac{V_{pv} + I_{pv} R_{se}}{R_{sh}} \right]$$

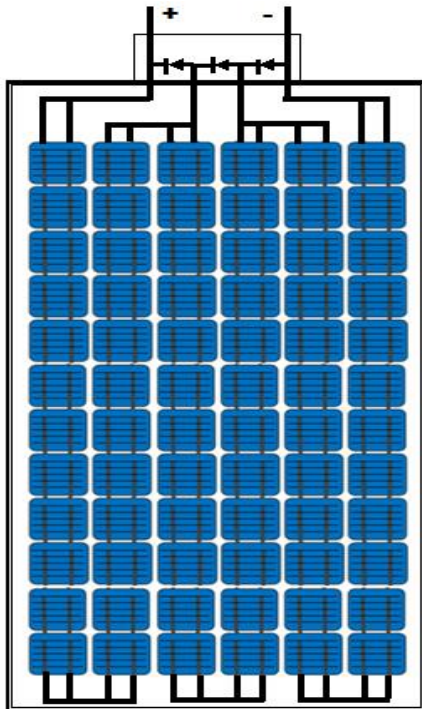
Mainly two technologies are used in solar photovoltaic first is Crystalline silicon type and second is Thin film type. The Crystalline Silicon photovoltaic panels are subdivided into Mono-Crystalline photovoltaic panels and Poly-Crystalline photovoltaic panels. Thin film photovoltaic panels can be Cd Te (Cadmium Telluride) photovoltaic panels, CIGS (Copper Indium Gallium Selenide) photovoltaic panels, and a-Si (Amorphous Silicon) photovoltaic panels [11]. A Mono crystalline solar photovoltaic module with 72 solar cells is shown in fig. 2. All cells are connected in series combination to get the desired output rating of solar module.

Fig.2. Mono-Crystalline Solar Photovoltaic Module

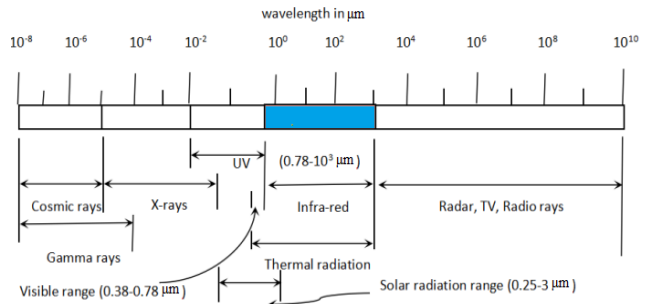
These infrared radiations were first discovered by Frederick William Herschel, a German Astronomer (1738-1822) in 1800 [12]. The spectrum of Electromagnetic spectrum is shown below representing

Fig.3. Infra red electromagnetic spectrum

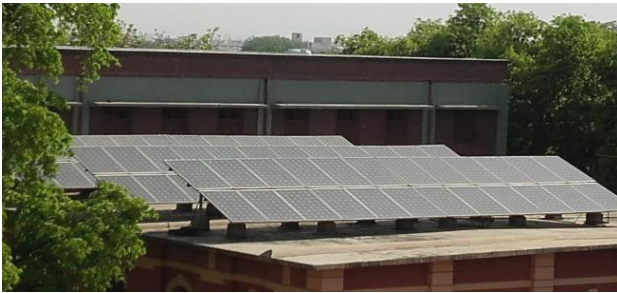
The solar panels were installed at the roof of a building with facing towards south in the campus of faculty of engineering, DEI, Agra. The building was surrounded by trees in plenty on eastern side and few on western side and there was a building on north side. The following fig. 5 shows the location of complete solar array and building roof with normally captured photograph.

Fig.5. Normal Camera Photograph of Complete Solar Array

The solar photovoltaic array consists of four strings i.e., string 1, 2, 3, 4. All these strings were connected in parallel with 18 modules in each. The following table 3 shows the number of solar modules in solar array.

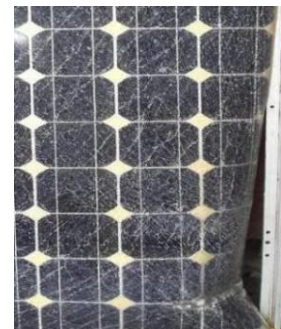
The frame of solar panels being exposed to direct contact of atmosphere develops corrosion, Deframing etc. Deframing occurs when frame of solar panels are detached due to ageing and other atmospheric conditions.

These defects in frame of solar panels are identified visually and are shown in fig. 6 and fig.7. Fig. 6 shows the corrosion at the connecting joints of solar module. Fig. 7 shows the de-framing of solar panel frame.

Fig.6. Corrosion at joints of Solar Panels, fig. 7 De-framing of Solar Panel Frame

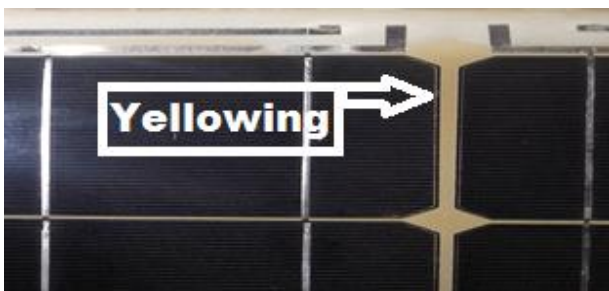
When poor quality material used in solar panels gets affected by temperature and other atmospheric conditions different problem arises. When the adhesive between solar cells and transparent glass surface is affected it is known as yellowing. The Fig. 12 shows yellowing of the panels due to the degradation of EVA (ethylene vinyl acetate).

Fig.12. Yellowing of Solar Panel Surface

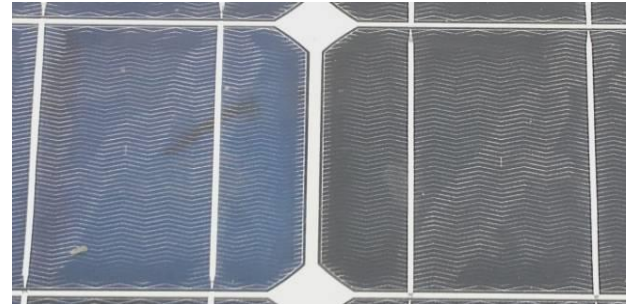
Discoloration of solar cell occurs when ARC (anti-Reflective Coating) starts to oxidize at high temperature and the color of the solar cell changes from purple to blue. The color of solar cell becomes blue from purple due to which less amount of solar irradiance is received by a solar cell. The de-coloring results into reduction of energy generated by a solar cell. Burn marks on bus bar occur when the temperature of a particular part in solar cell becomes very high. The bus bars get

Figure 13 shows the discoloration defect on the solar cell. The color of the left solar cell is less blue than the right solar cell which is dark blue. Burn marks on the bus bars are shown in fig. 14.

Fig.13. Discoloration of Solar Cell

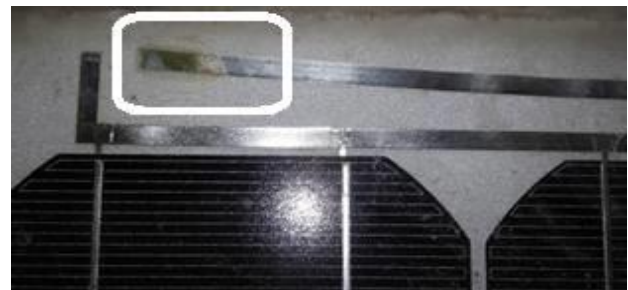
Fig 14 Burn Marks on the Bus Bars (in square)

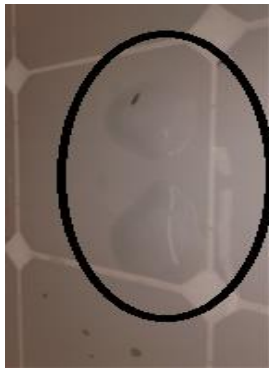
Fig. 15

There are three common visual defects at the back sheet of solar panels. First is evolution of bubbles, which occurs when heat of the solar cells is dissipated from back sheet surface. Due to the chemical reaction of Encapsulant some gases are released during the heat dissipation and an air chamber is formed at the back sheet surface of solar panels. This air chamber is known as bubble. The temperature of nearby cells to the bubble becomes high because of less dissipation of heat. Rupture is due to high temperature and mishandling of solar panels when they are transported from one place to another. When back sheet surface of solar panels are not laminated or the quality of back sheet material is poor the problem of chalking powder arises. The thermal degradation or poor quality materials used at the back sheet of solar panels result into a white powder known as chalking powder. It can fail back sheet insulation and electrical shock. Therefore the back sheet surface of solar panels are laminated to get better finish, durability and safety against any kind of degradation defects as well as faults. The fig. 15 shows two bubbles (shown by black circle in figure) identified at the back sheet surface of solar panels and fig. 16 shows a rupture observed at the back sheet surface of solar panel (a close up of rupture is shown by an arrow in figure). The fig. 17 shows two solar panels with un-laminated and laminated back sheet surface along with chalking observed from un-laminated back sheet surface.

Fig.15. Bubbles at the Back Sheet Surface of Solar Panel, fig. 16 Rupture at the Back Sheet Surface of Solar Panel

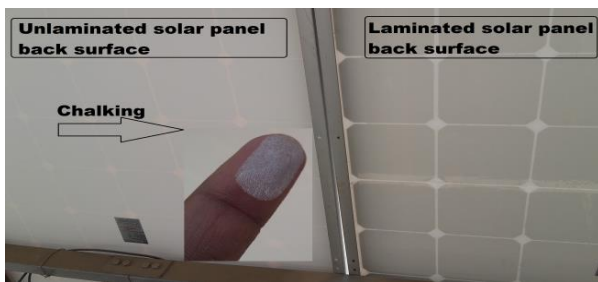
Fig.17. Chalking at the Back Sheet Surface of Un-laminated Solar panel

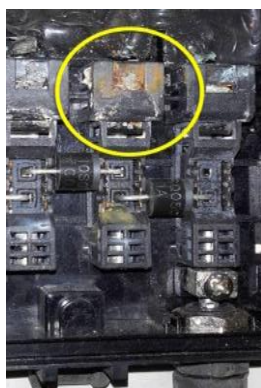
Junction box is placed at back sheet of solar panels. The problems are due to moisture, corrosion, heating of its components and lack in the maintenance.

Fig. 18 and fig. 19 shows corrosion in the junction box components and moisture at the cover of junction box respectively.

Fig.18. Corrosion inside Components of Junction Box, fig. 19 showing Moisture at Junction Box respectively

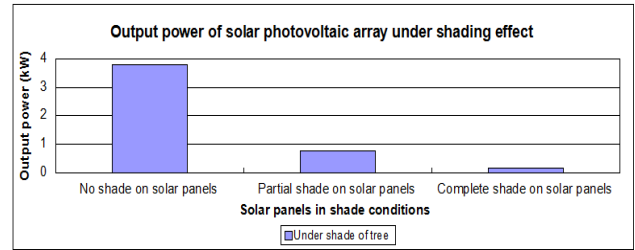
showing low temperature represented by dark color. The fig. 36 shows variation of output power of solar panels under shade conditions of tree.

Fig.36. Variation of Output Power of Solar Photovoltaic Array under Shading Effect of Tree

The above table 4 shows that the output current as well as output power of solar photovoltaic array reduces as solar panels come under the shade of tree. It also represents variation in temperature of bird beat, cement deposits, bubbles and other parameters. Presence of all these problems affects the solar power generation. The output current and output voltage was measured without

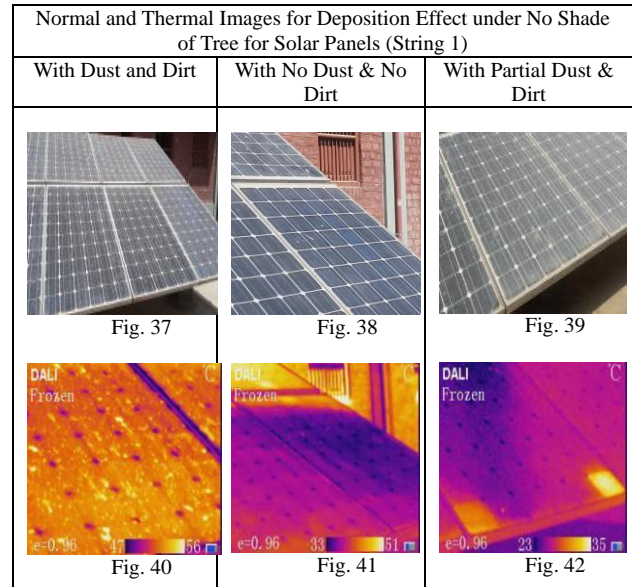
In this case the solar photovoltaic panels were found to have soil deposition, small pallets of cement deposition, bird beat deposits and bubbles but shading of tree was common between all. Table 5 shows deposition effects mainly soil, bird beat, cement deposits with electrical and thermal parameters under no shade of tree. Table 6 shows deposition effects mainly soil, bird beat, cement deposits with electrical and thermal parameters under shade of tree. The table 5 and table 6 shows the effect of soil depositions, cement deposition and bird beat depositions on solar panels with no shade and with shade of tree. It has been noticed that output power decreases as the dust, depositions change according to the atmospheric conditions.

Fig.37. to fig. 42 Shows Normally Captured Photographs and Thermal Images of Deposition Effects for Solar Panel String I under No Shade of Tree

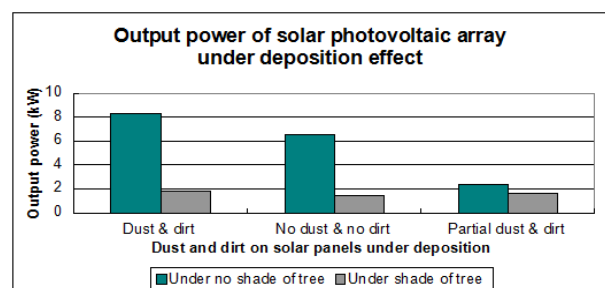
Fig.49. Bar Chart for the Change in Output Power due to Depositions under Shade and under No Shade of Tree

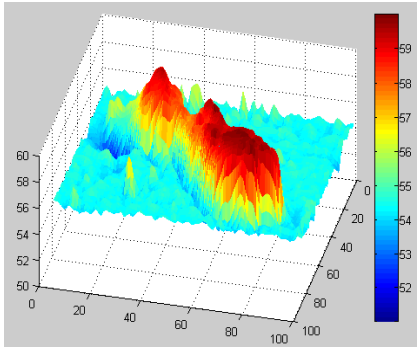
3D Temperature Plot

S. No.	Name of Deposit/ Defect	Type of Image (Normal/Thermal/Segmented/3D)
1.	Bird Deposit on Surface of Solar Panel	Normal Image Thermal Image Segmented Image

The table 7 shows the normally captured photographs, thermal images, and 3D temperature plot of bird deposit, cement deposit and hotspot found on the surface of solar panels. The image processing is helpful to get the temperature of different depositions (bird deposition, cement deposition) and defects (hotspots, bubbles) evolved in solar panels when operated under natural atmospheric conditions.

The thermal image shows heat emitted by the object on solar panel surface. When image segmentation is applied to thermal images, the desired hot portion is segmented from thermal image and shown with pseudo-colors.

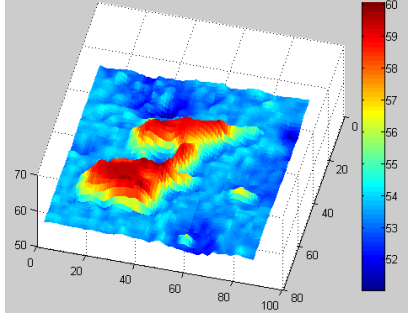
3D Temperature Plot

2.	Cement Deposit on Surface of Solar Panel	Normal Image Thermal Image Segmented Image

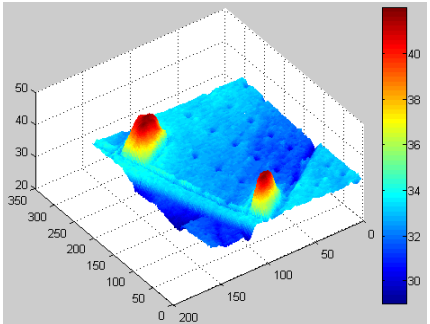
3D Temperature Plot

3.	Hotspots on Solar Panel Surface	Normal Image Thermal Image Segmented Image

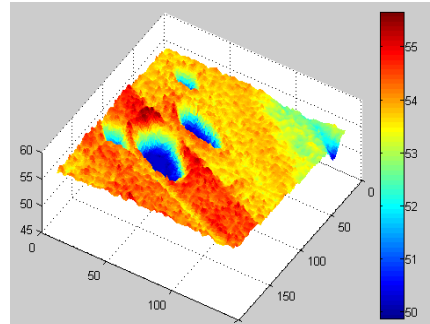
3D Temperature Plot

4.	Bubbles at the Back Sheet Surface of Solar Panel	Normal Image Thermal Image Segmented Image
